The
San Francisco Earthquake and Fire

A BRIEF HISTORY OF THE DISASTER

A. L. A. HIMMELWRIGHT, C.E.

THE ROEBLING CONSTRUCTION COMPANY
FULLER BUILDING, NEW YORK, N. Y.

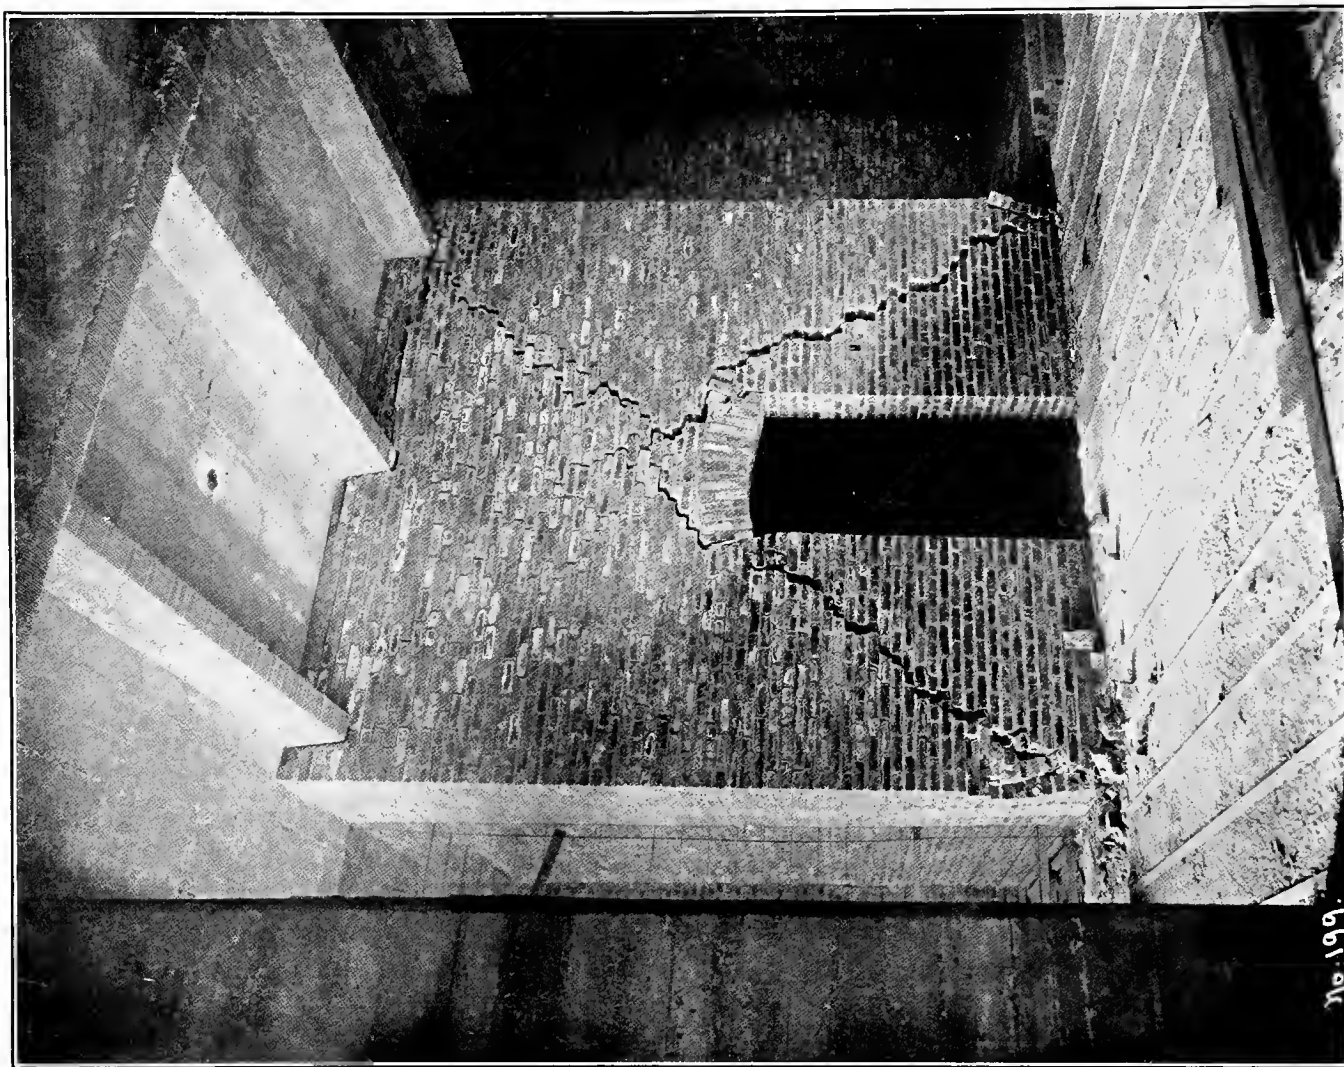
CALIFORNIA CASKET CO.'S BUILDING. Second Story. Showing the earthquake damage to a brick vault built between the Roebbling concrete floors. A similar vault on the first floor was completely destroyed. In the upper stories, the vaults were similarly but less damaged by the earthquake. The Roebbling crimped wire is in position on the soffits of the beams and girders ready to receive the cement plaster. The column at the left-hand side is protected with concrete by the Roebbling method.

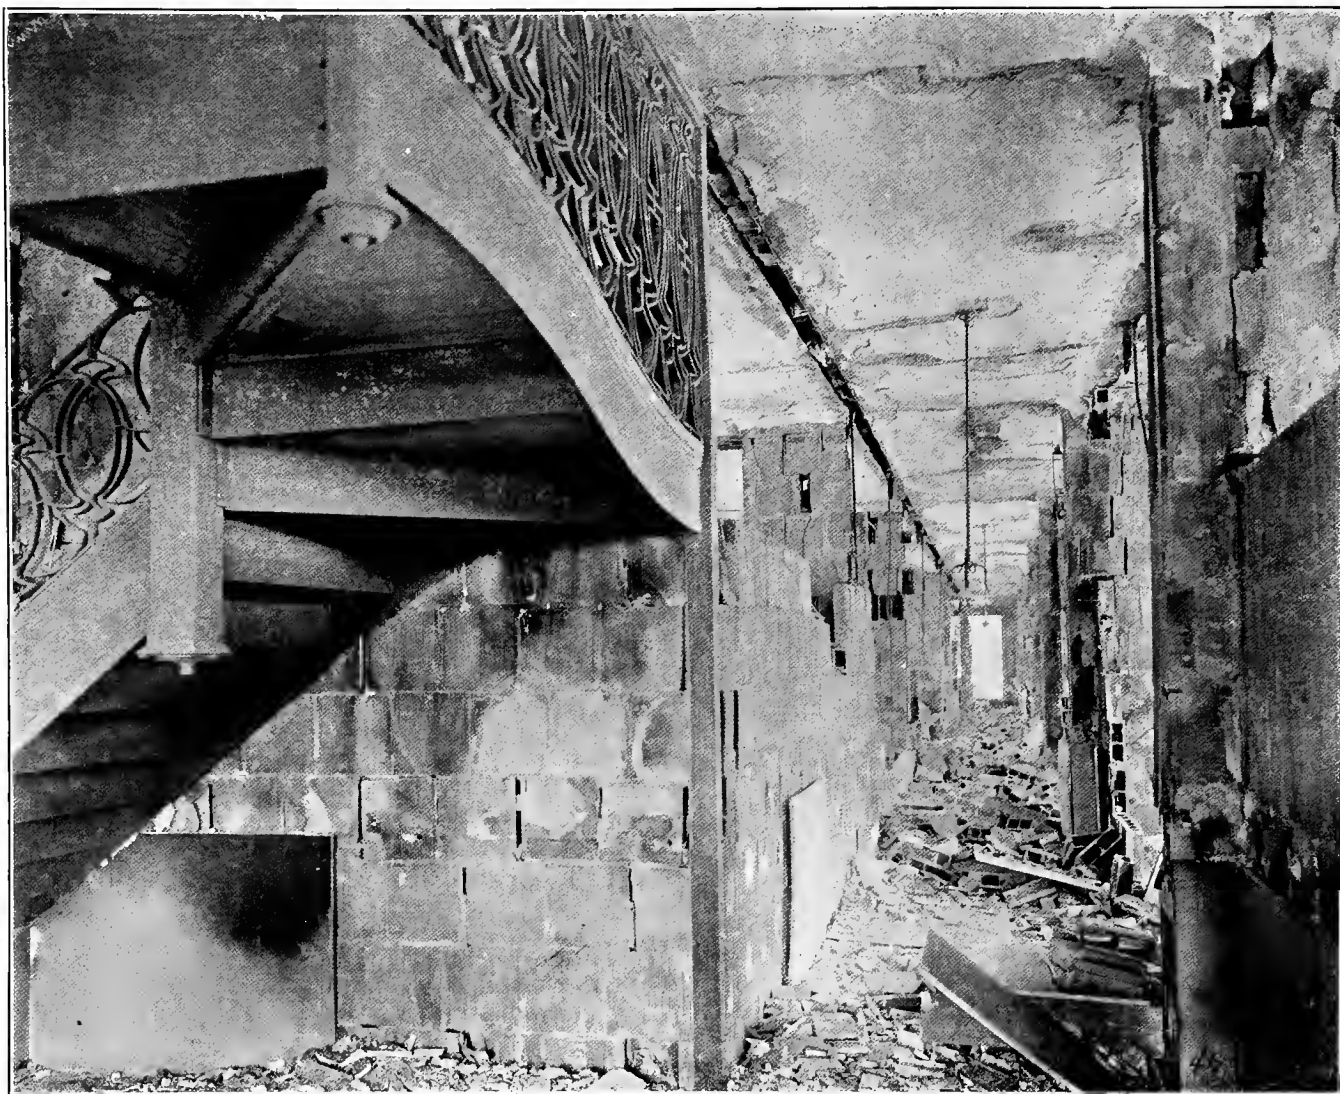
GRANT BUILDING. Typical view showing the damage to the hollow-tile column protection and the failure of the hollow-tile partitions. The Roebling concrete floors and wire lath and plaster ceilings are in good condition throughout.

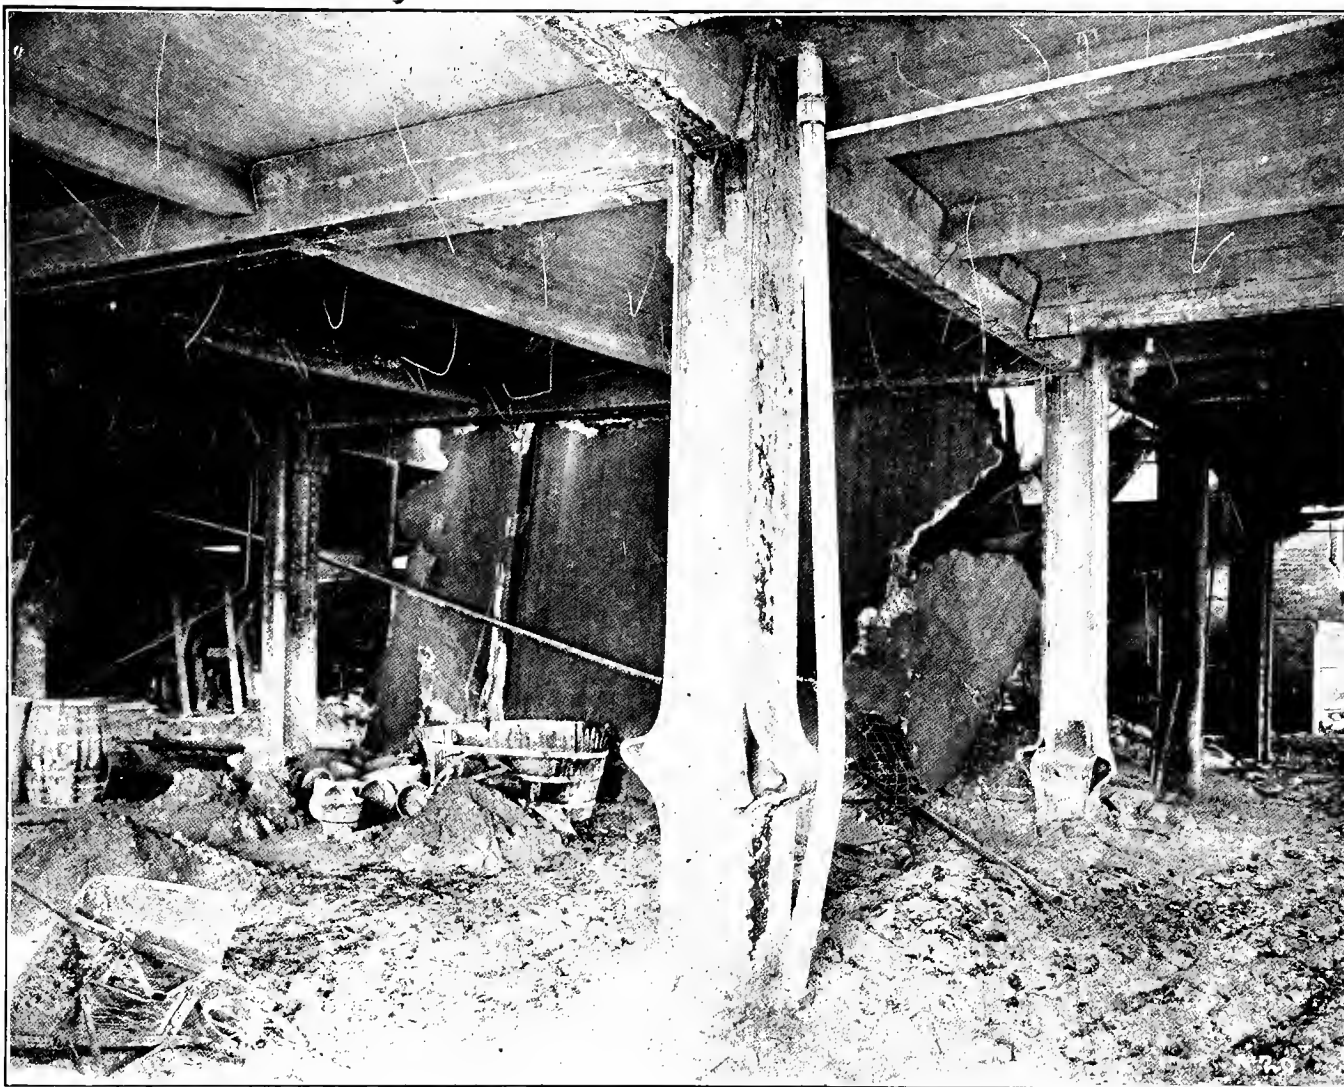
In the basement story where the column protection had not yet been placed, a pile of lumber for scaffolding caused the buckling of two columns and the deflection of some steel beams and girders that were exposed. A charge of dynamite on the west side of this building disrupted an entire bay between four columns of the first floor, breaking the connections of the beams and girders at the columns and causing the entire floor section to drop to the basement. The wire lath and plaster ceiling of the third story, immediately above this bay, was also destroyed, portions hanging in shreds by the original fastenings. Three reinforced concrete beams adjacent to the bay that was destroyed by dynamite, are badly shattered. The steel girders and concrete protection around them, which support the reinforced concrete beams, although nearer to the disrupted bay, are uninjured. The dynamiting also caused considerable damage to other portions of the work on this side of the building.

MONADNOCK BUILDING. First Floor. Showing the effect of dynamiting. One complete bay was entirely disrupted, the steel connections of the beams and girders being broken, allowing the mass to fall into the basement and wrecking the expanded metal lath and plaster ceiling of the floor directly above it.

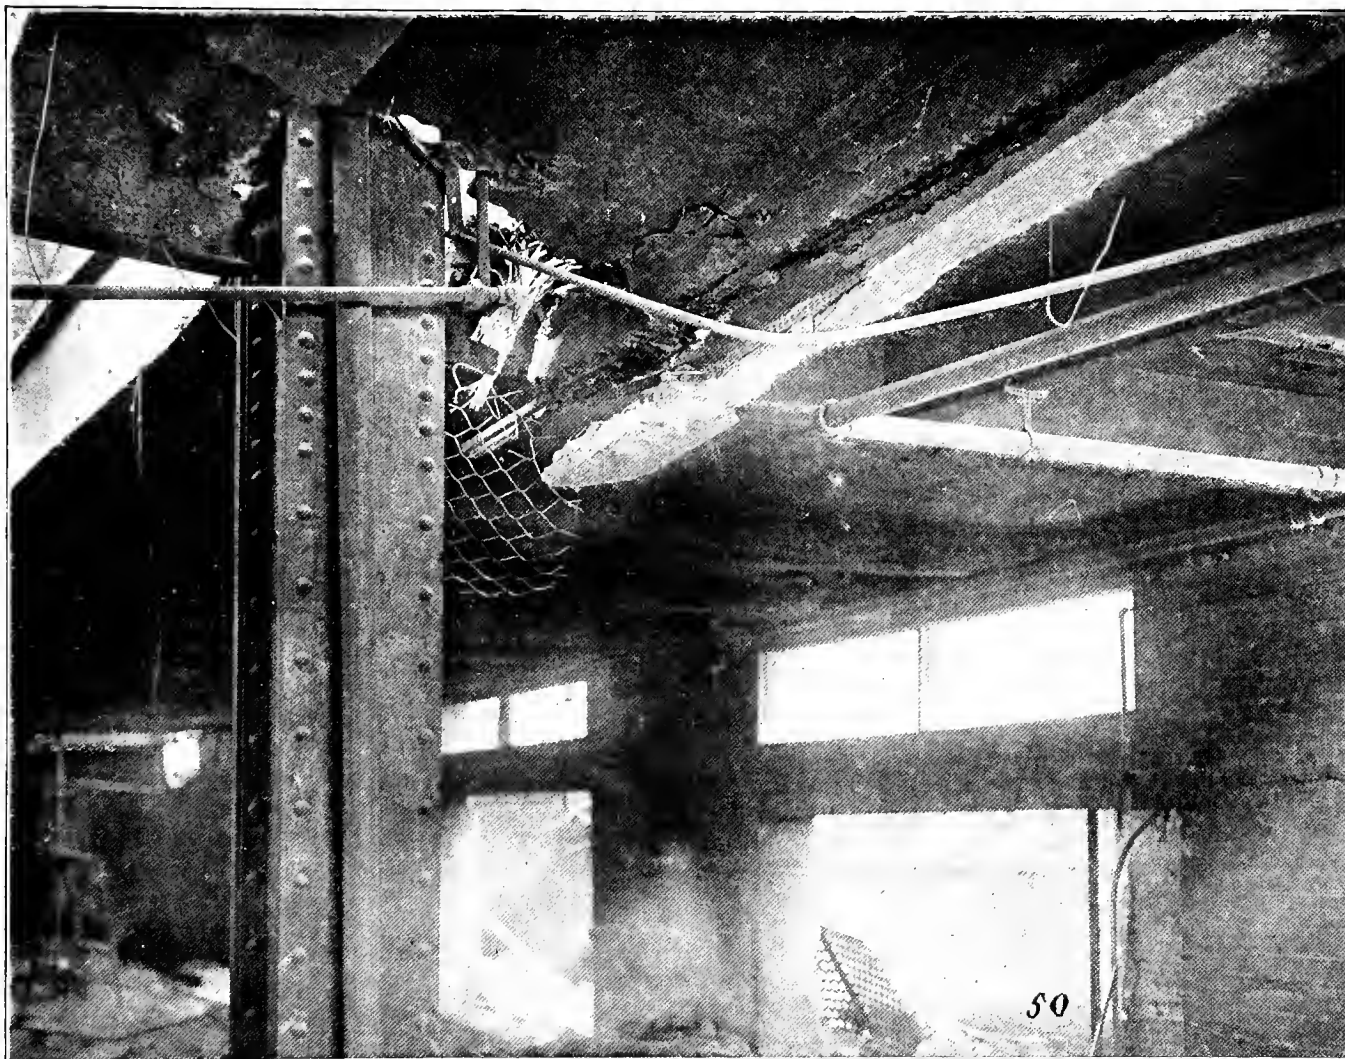
MONADNOCK BUILDING. Basement Story. Showing buckled columns caused by the burning of scaffolding lumber piled around them. The bay of floor construction standing on edge in the centre was broken out by dynamite. The building was in the course of construction, and the protection of the columns had not yet been placed.

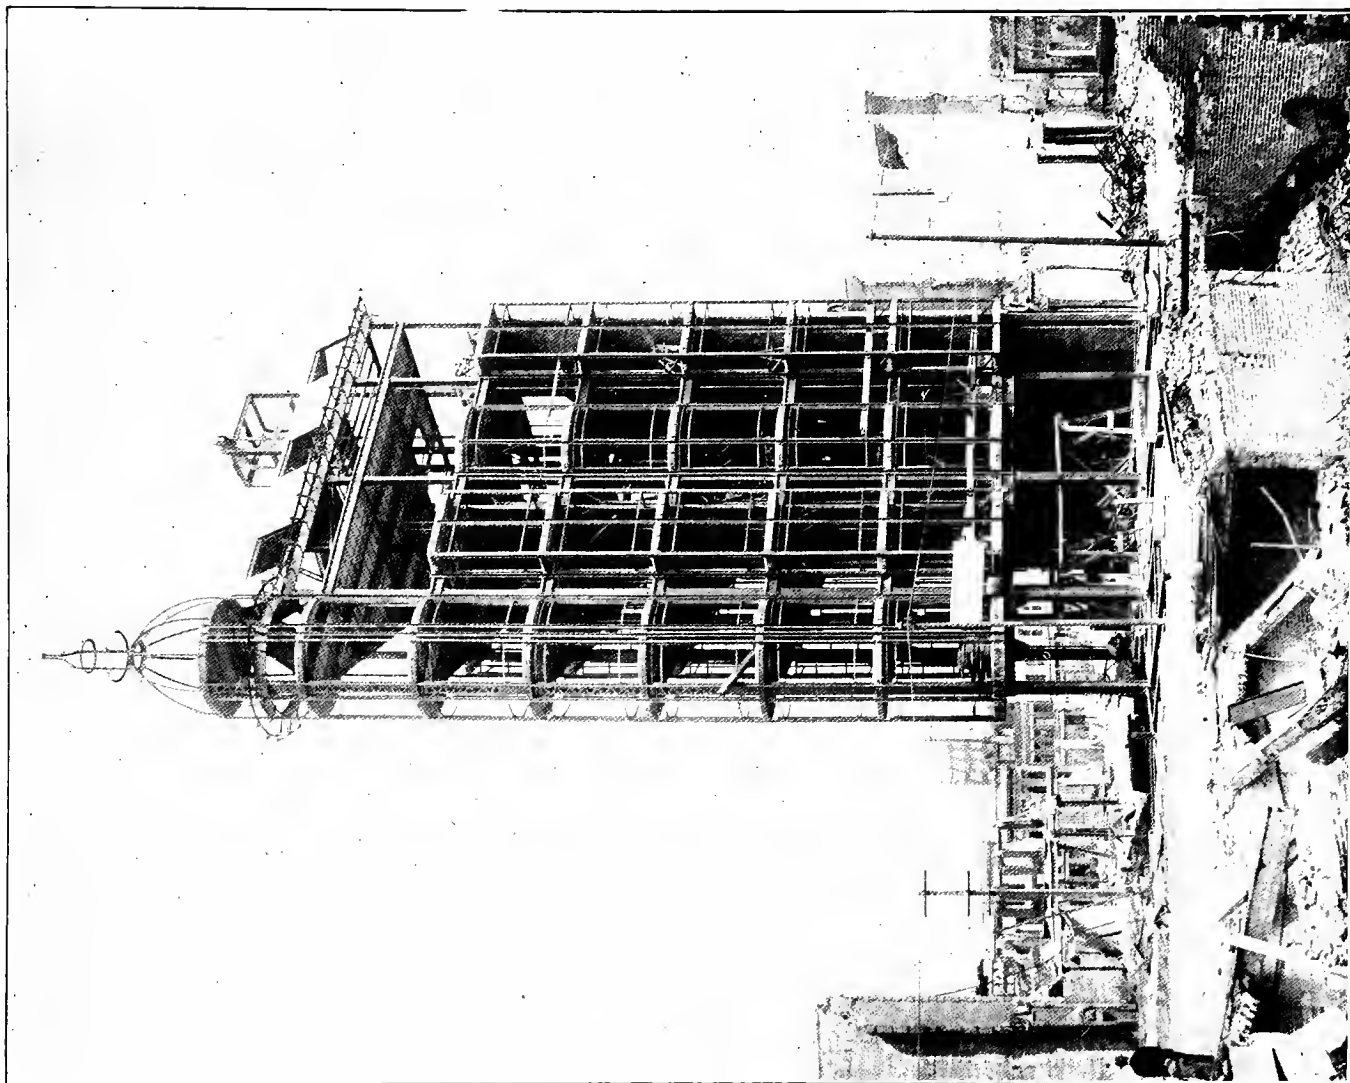
RUEF BUILDING. Junction Montgomery Avenue and Kearny Street. This building was in course of construction, with the steel frame and fire-proof floors completed. Only a portion of the rear brick wall has been carried to the sixth story. The Roebing fire-proof floors and the steel frame are uninjured. This building sustained no serious structural damage from the earthquake or the burning of adjacent buildings.

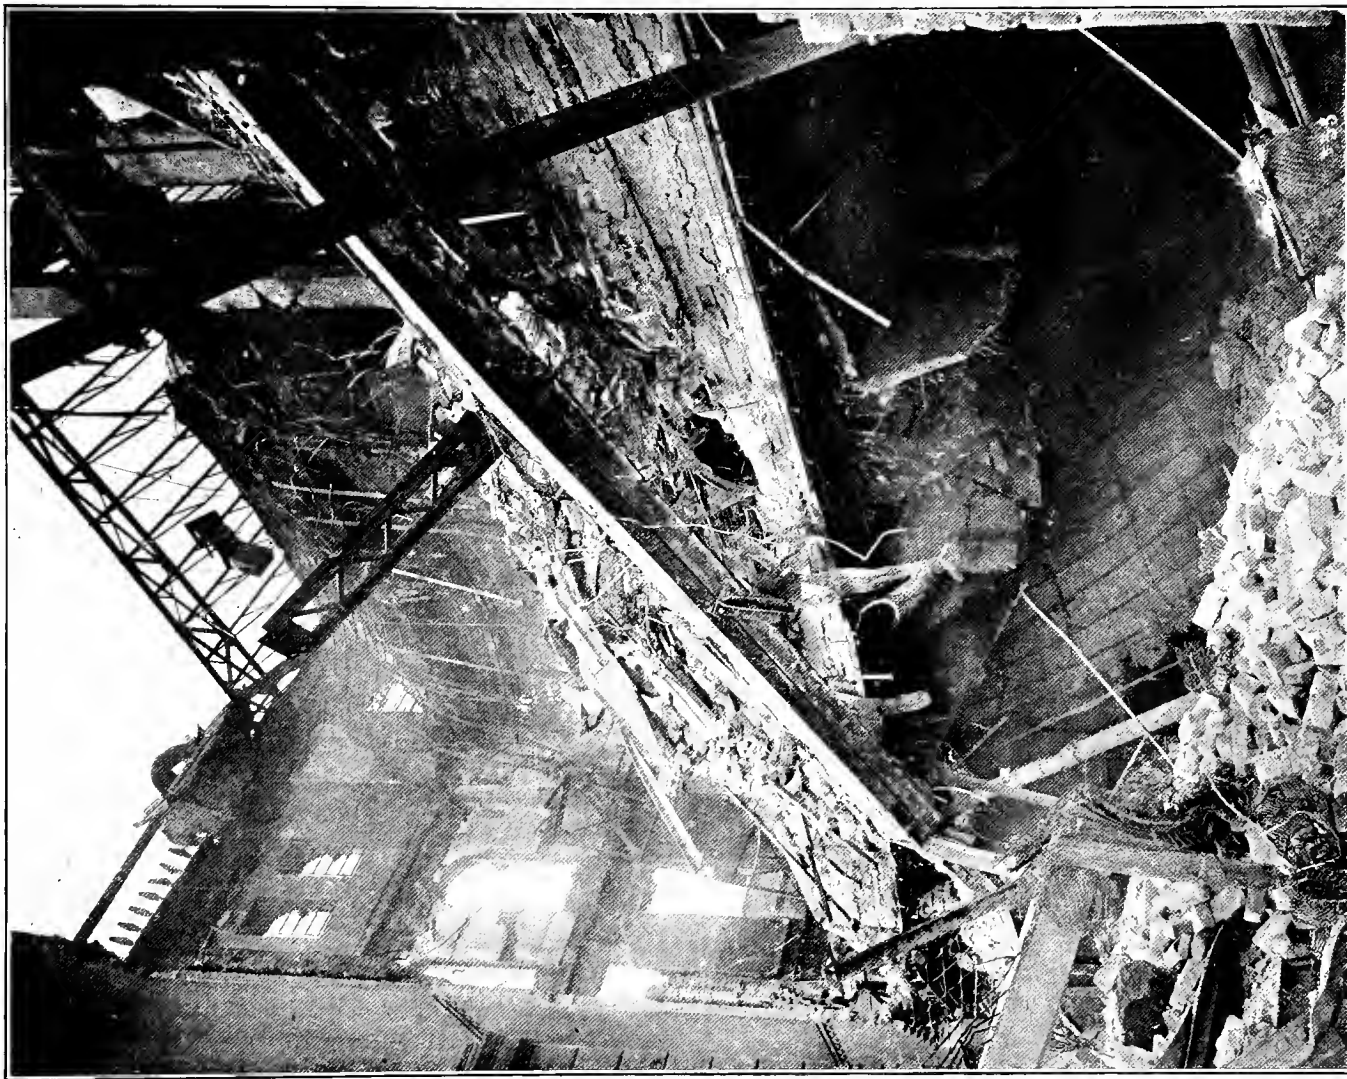
HALL OF JUSTICE. S. E. Cor. Kearny and Washington Sts. The façades consist of Colusa sandstone for the first story, and buff terra cotta brick and terra cotta ornaments above. The front of the building, excepting the tower, cornice and balustrade parapet, is but slightly damaged. The entire rear portion of the building and the tower are wrecked. The dome over the tower was of light steel framing, covered with galvanized iron. When fire entered the tower, the light steel members quickly failed, causing the dome portion to fall over in a horizontal position. Most of the damage to the mason work of the tower was caused by the earthquake.

HALL OF JUSTICE. From the alley at the rear, looking into the rear half of the building which was wrecked. The suspender system of expanded metal floors was used in this building. This view shows the partial failure and sagging of the first floor arches under a heavy overburden of *débris*. In the upper stories the suspender bands are hanging in a vertical position from the parts of the building that remain standing. The rear wall was only 8" thick between pilasters and was about 60 feet high. Lime mortar of poor quality was used in this building.

caused by the failure of one or more of the large trusses supporting the roof. The wood roof over the roof houses, and other wood-work around the cornice and the upper portion of the building, no doubt, contributed to the heat which caused the failure of these trusses.

It was noted that the rear wall between pilasters was only 8" thick for a height of about 50 ft. Much less damage would have resulted had this been a steel skeleton frame building, with the walls supported by the steel work.

While the front is but slightly damaged, the wreck of the rear portion and the tower is so extensive that in all probability the building will require total reconstruction.

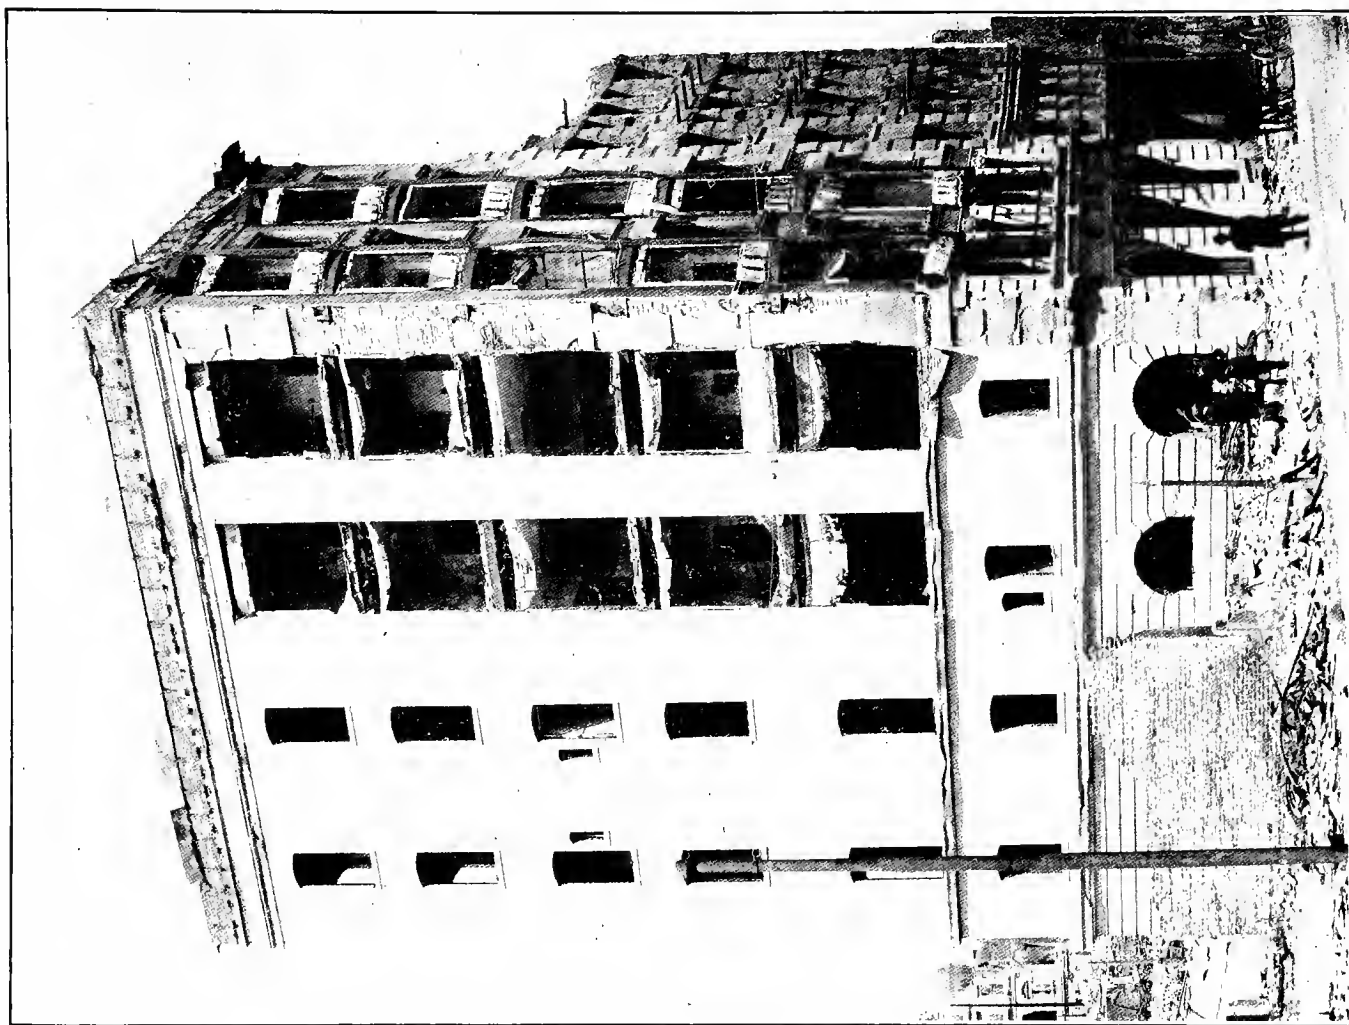
In the second story there is a buckled column near the centre of the building. On the east side are outside tie beams crossing the light well. These have been considerably buckled and deflected by the heat.

The column protection was not first-class and failed to prevent the buckling of a column in the second story. The concrete stairway is uninjured, but some of the wrought-iron pipe supports are slightly deflected.

The tie beams across the light court in this building were exposed and were damaged by the heat from the fire of adjoining buildings. Structural ties of this character are very generally used and are frequently left exposed. The expansion of such members no doubt causes abnormal stresses before the steel becomes sufficiently heated to buckle or deflect. Such consequences should be avoided by suitable protection. Their exposure to the weather in positions where they are usually inaccessible for painting, is also injurious, and consequently objectionable.

TURKISH BATHS. 632 Post Street. Excepting the southwest corner, which is badly cracked and spalled, the terra-cotta facade is but slightly damaged. A few earthquake cracks are visible in all the walls. There is a buckled column in the second story near the centre of the building. The bay windows were of wood construction. The cinder concrete floors remain in good condition. The metal lath and plaster ceilings, partitions and column covering are considerably damaged, but remain in position.

The repairs to the exterior of this building will be comparatively light. The replacing of the buckled column should not be a very serious matter. The rest of the repairs are limited to the restoration of the interior finish.

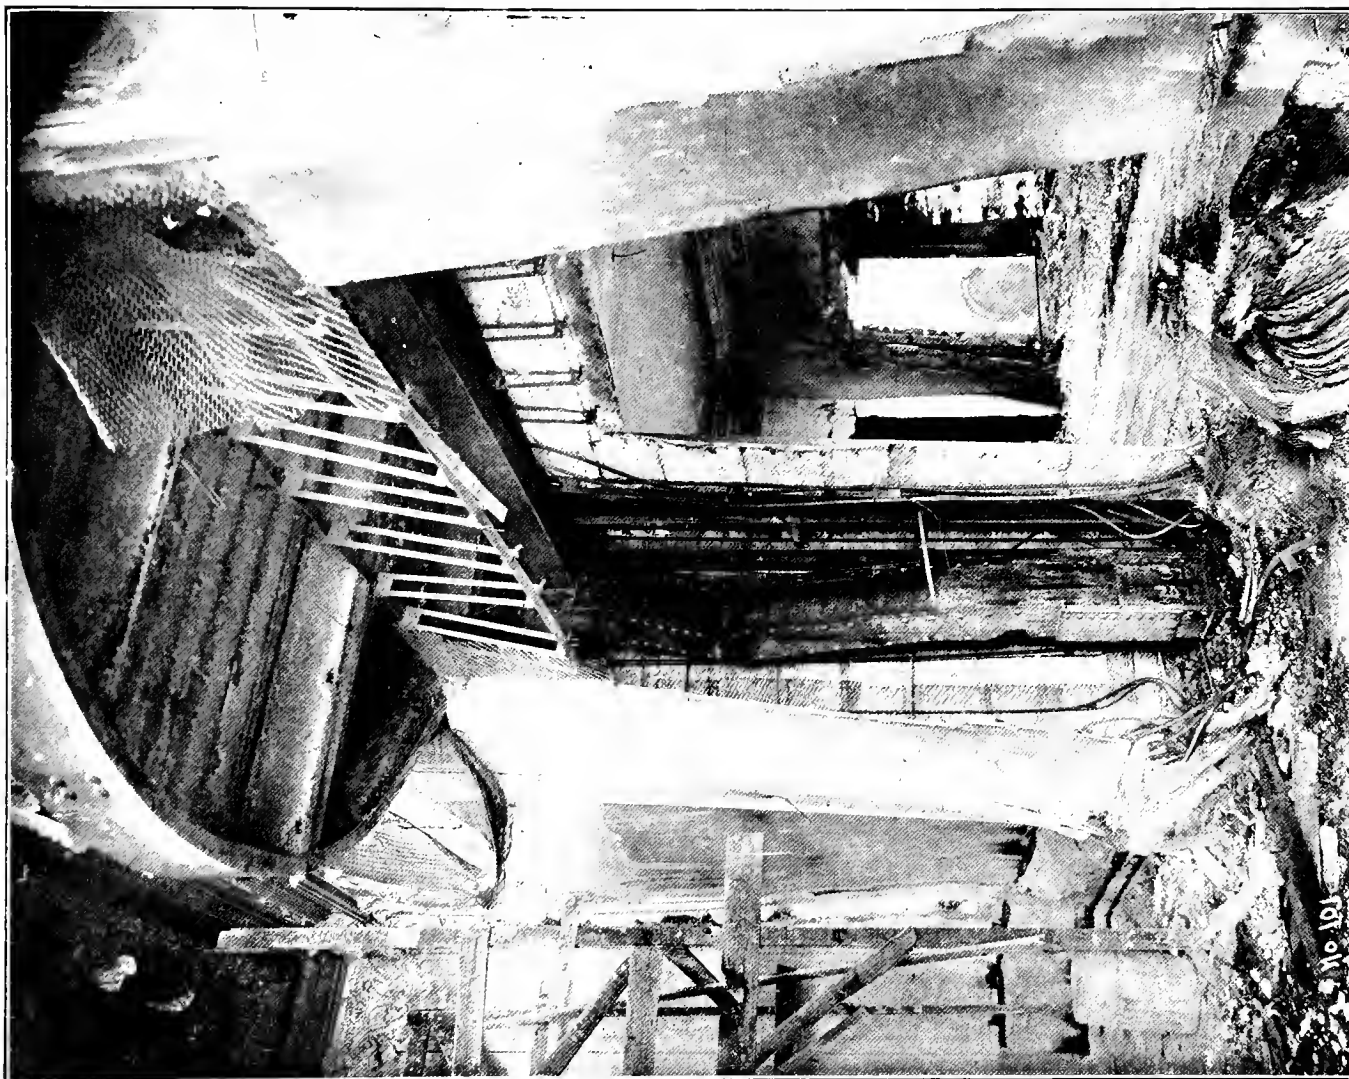
FAIRMONT HOTEL. Powell, Sacramento, Mason and California Streets. The façades, consisting of gray granite for the first story, and cream-colored terra cotta above, are but slightly damaged. The terra cotta around some of the window openings is spalled, and at the third-story level of the east side considerable damage has been wrought by the earthquake. The interior of this building is in bad condition on account of the buckling of between 30 and 40 columns, causing the floors to have a wavy effect and buckling and distorting the partitions in the upper stories. The buckling of the columns was caused by insufficient fire protection, many of them being simply within blind spaces enclosed by expanded metal lath and plaster partitions, and without independent protection. The metal lath and plaster ceilings fell in many places, on account of a weak wire clip which was used to support them. Notwithstanding the warped and distorted condition of the steel work, not a single span of the expanded metal concrete floors dropped out. Repairs to the exterior will be comparatively small, but almost the entire interior will require reconstruction.

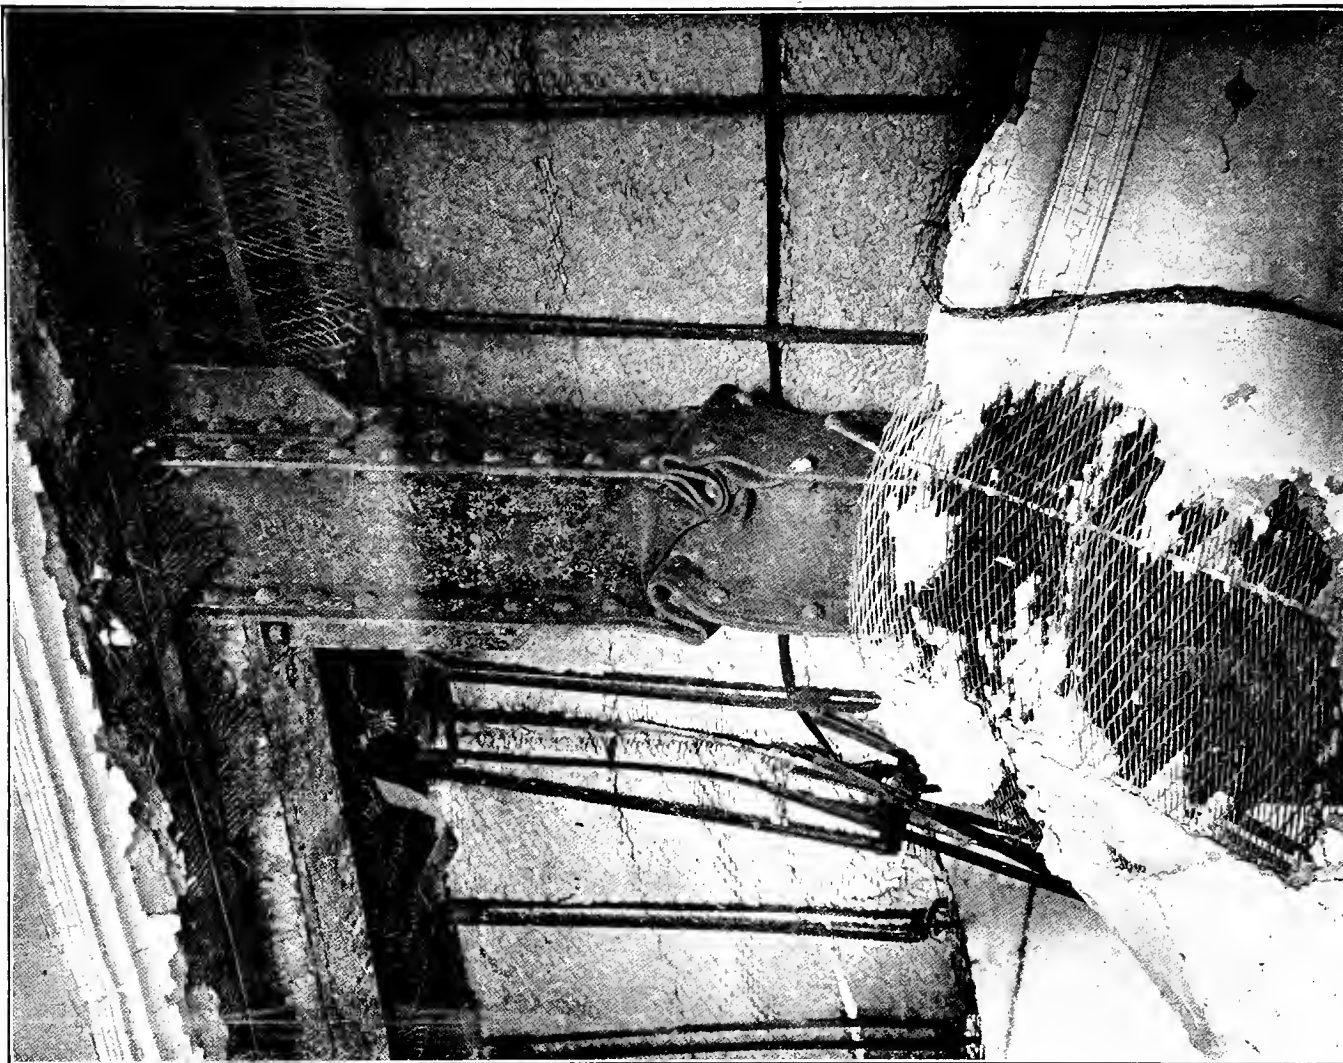
FAIRMONT HOTEL. First Story. From the ball room, looking through the doorway into the corridor. Showing a buckled column that was simply enclosed in a large blind space between partitions. The latter were nowhere less than 18' away from the column. The settling of the column deflected and buckled the partitions as shown.

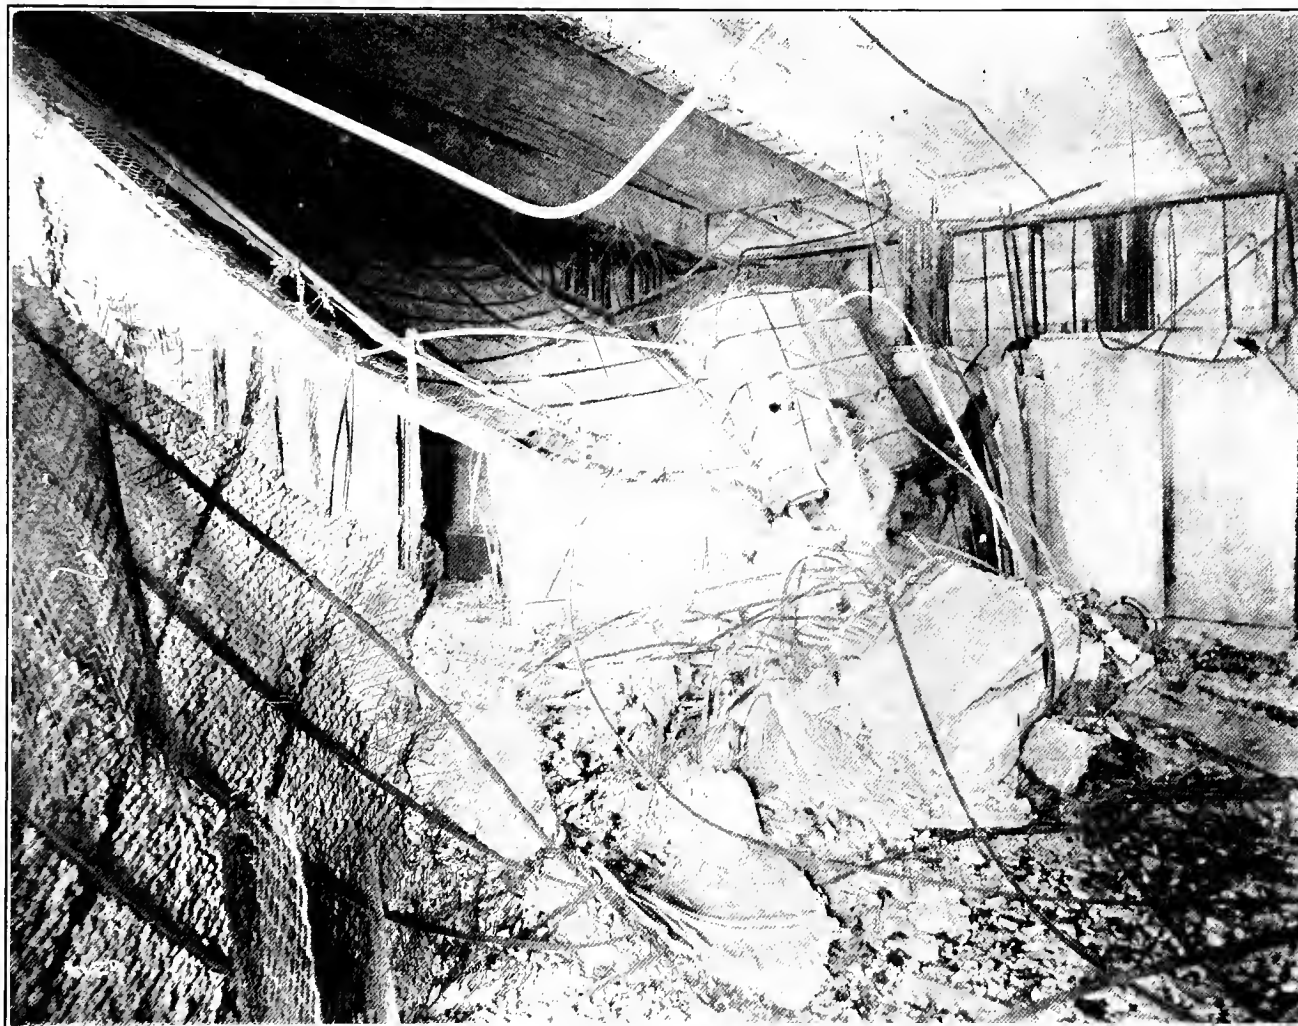
FAIRMONT HOTEL. Third Story. Showing a badly buckled column, which was simply enclosed between metal lath and plaster partitions without independent protection. The partition leaning against the lower half of the column originally stood along the line where the plastered cove is ruptured at the ceiling.

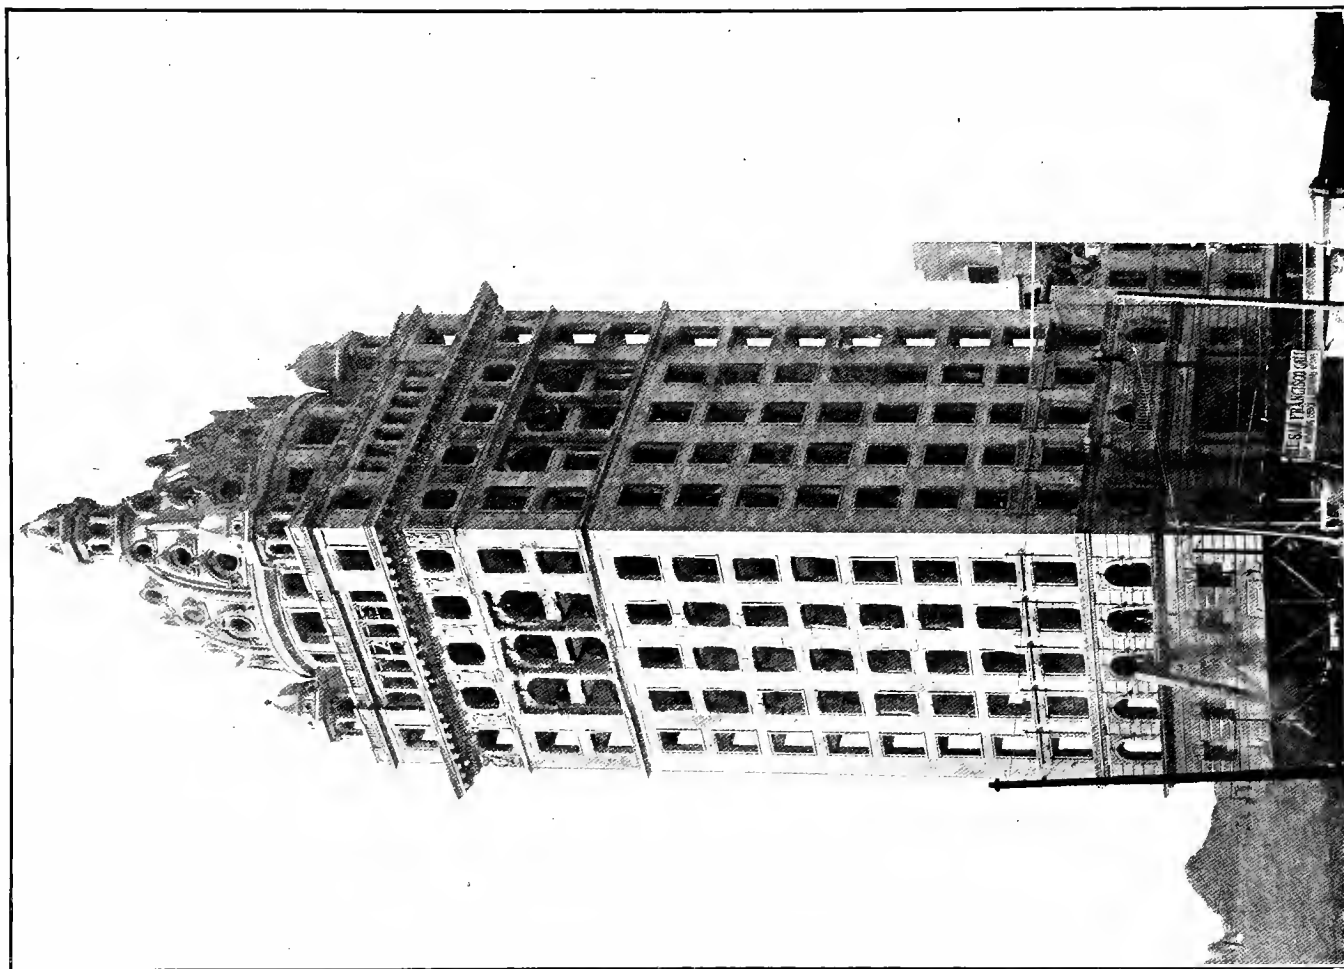
CLAUS SPRECKELS (OR CALL) BUILDING. S. W. Cor. Third & Market Sts. The façades are of Colusa sandstone. The entire Third St. front is badly scaled and spalled by the fire. The south front is also similarly damaged, but in a lesser degree. The Market St. front is in good condition, only a few window openings being damaged. The west front, while considerably more damaged than the Market St. side, can be repaired. The foundations remain level, and the walls plumb. The steel skeleton frame is uninjured. The concrete floors throughout are in first-class condition. The hollow tile partitions, column covering and wall furring have been greatly damaged and are in bad condition. This is the tallest and most celebrated building in San Francisco, and is structurally uninjured.

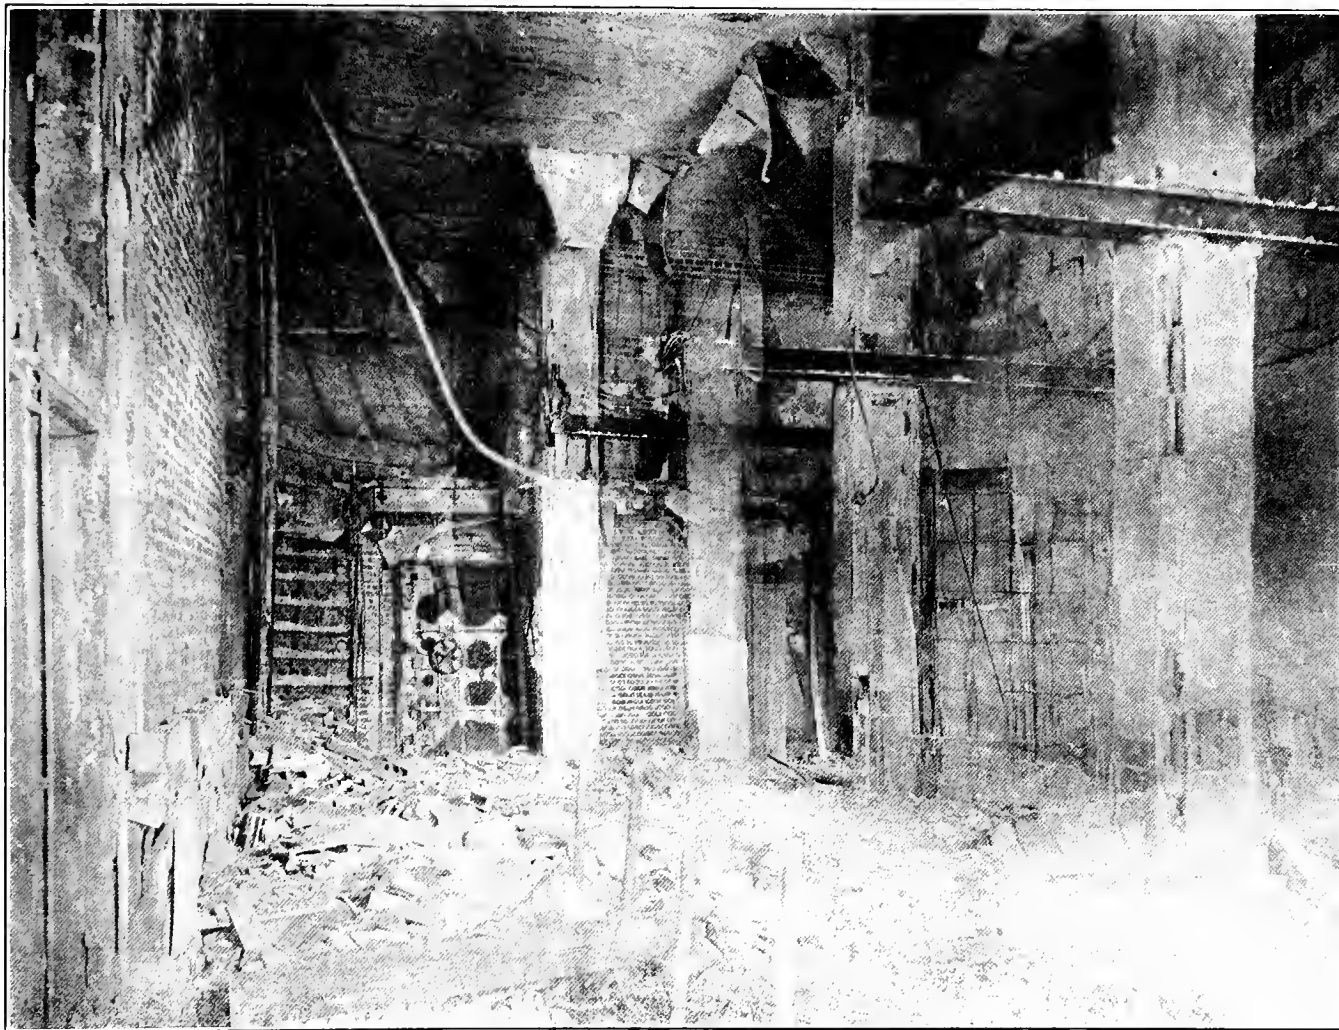
CLAUS SPRECKELS BUILDING. First Story. Showing the damage to the hollow tile wall furring, column covering, hollow wire lath partitions and wire lath ceiling. Note the hollow tile *débris* on the stairway at the left. The stairways in this building were totally wrecked by hollow tile and other *débris*. The concrete floors are in first class condition throughout.
